## [HowTo] eliminate mechanical backlash in ThinkPad Hinges (all classic Series)

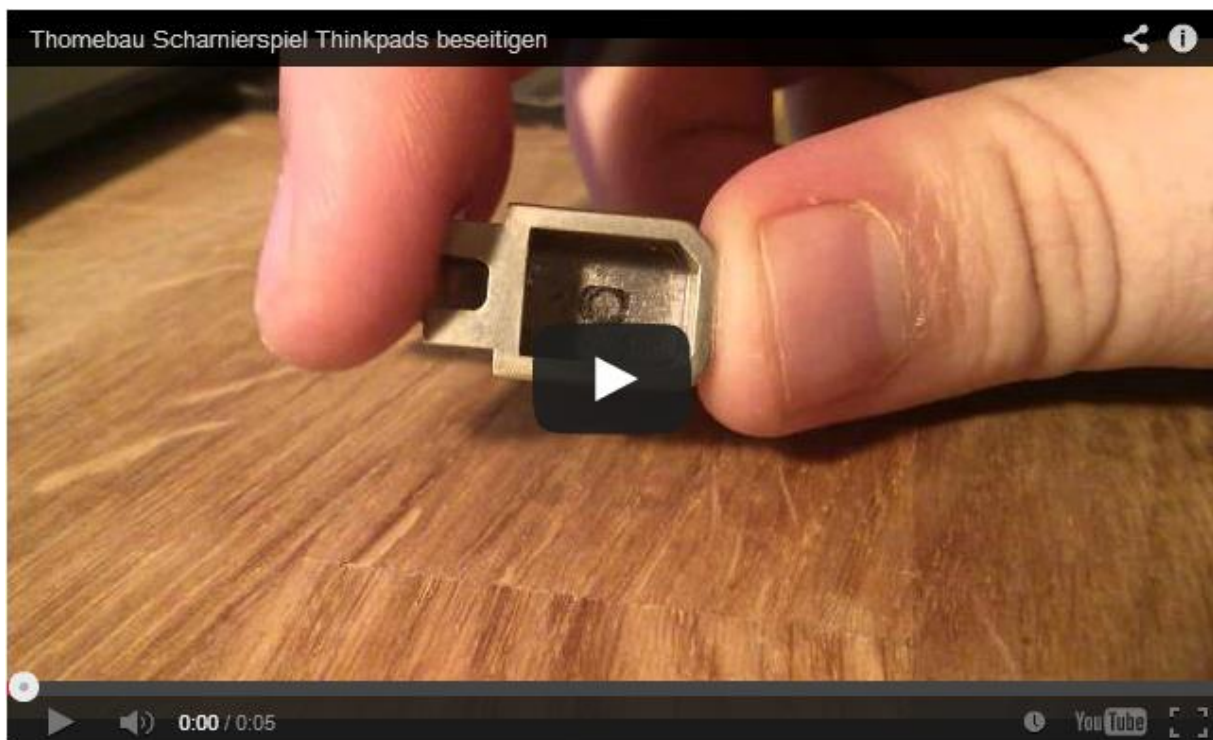
And this is the point where we get our backlash after a few hundred load cycles. This is due to the non-perfect fitting between the shaft and the lower bearing, where the entire load is hold only by the knurling. As soon as there is a little bit of backlash it starts to increase very fast before it reaches the maximum backlash, only limited by the flattened edge turning inside the lower bearing. Due to the long lever the backlash can reach up to 30mm at the upper edge of the LCD cover.

Then your hinges are pretty worn out, you should be able to disassemble them with ease. Just pull the shaft out of the lower bearing.
